AFWAL-TR-82-2121
Volume I

STRUCTURAL ELEMENT AND REAL BLADE IMPACT TESTING

UNIVERSITY OF DAYTON RESEARCH INSTITUTE
300 COLLEGE PARK AVENUE
DAYTON, OHIO 45469

FINAL REPORT FOR PERIOD OCTOBER 1977 - JUNE 1980

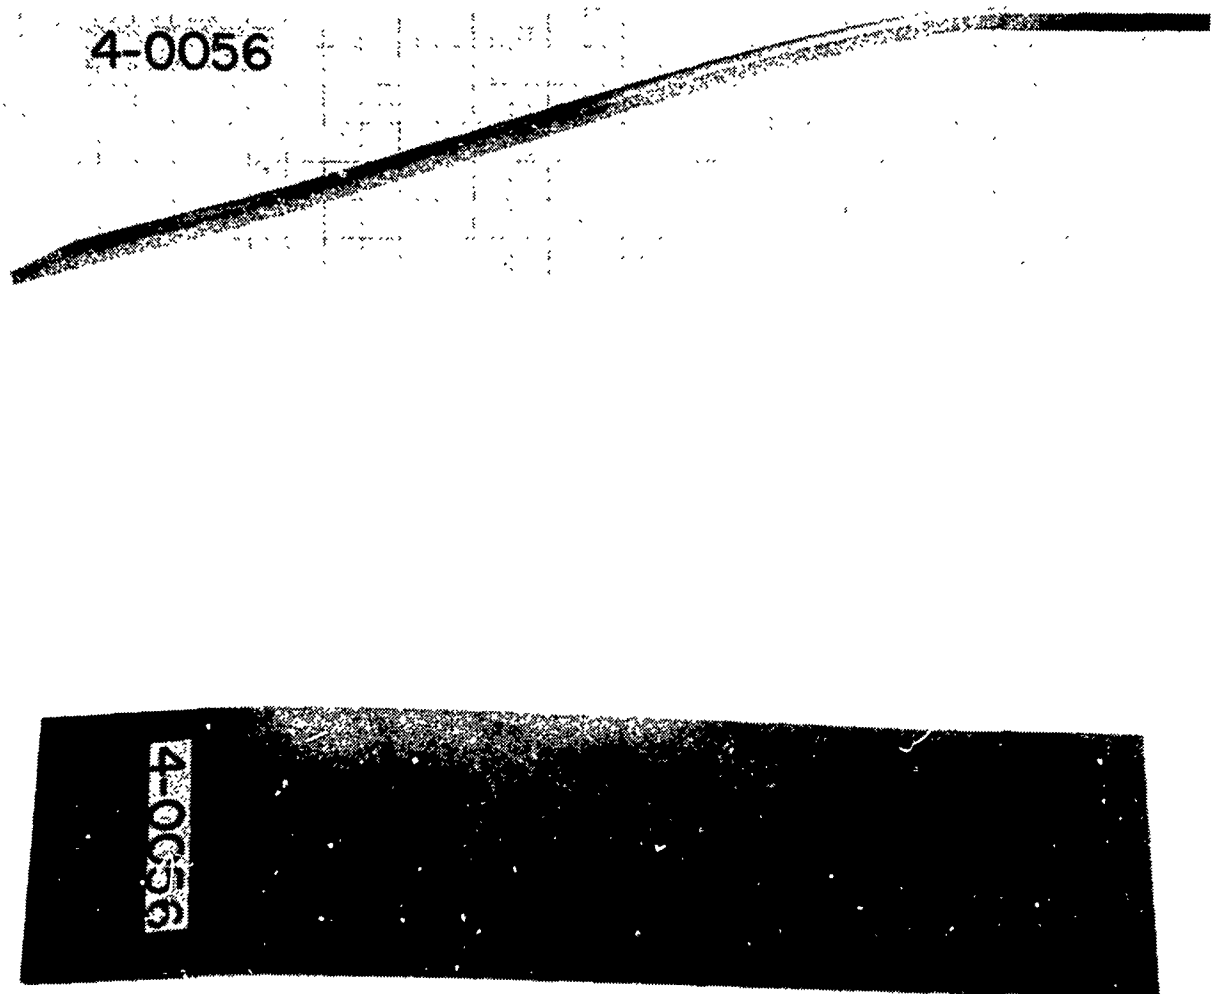
Figure 1B. Damage for Group 1 Titanium Specimen Due to 85 g
(3 ounce) Artificial Bird Impact (Shot 4-0056).

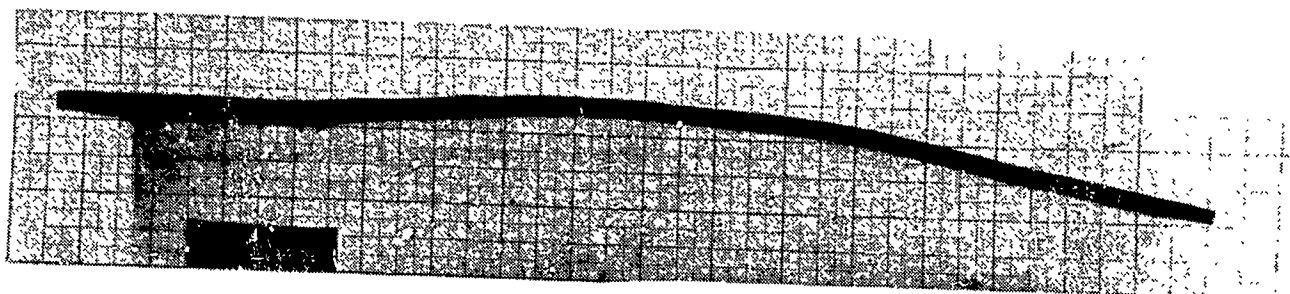
Figures 4B and 5B of Appendix B show photographs of the damage for Shots 2-0173 and 2-0174, respectively.

Figure 5B. Damage for Group 2 Titanium Specimen for 5.08 cm Diameter Ice Ball Impact (Shot 2-0174).

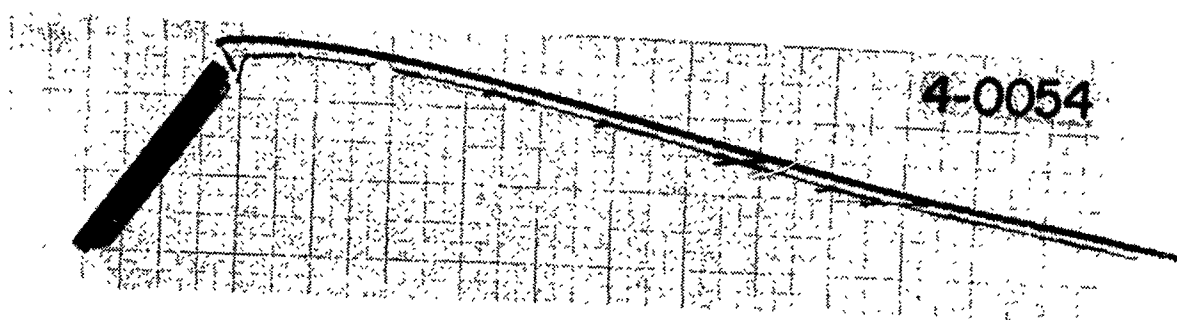
Figure 11B. Damage for Group 6 Titanium Specimen for 85 g
(3 ounce) Artificial Bird Impact (Shot 4-0054).

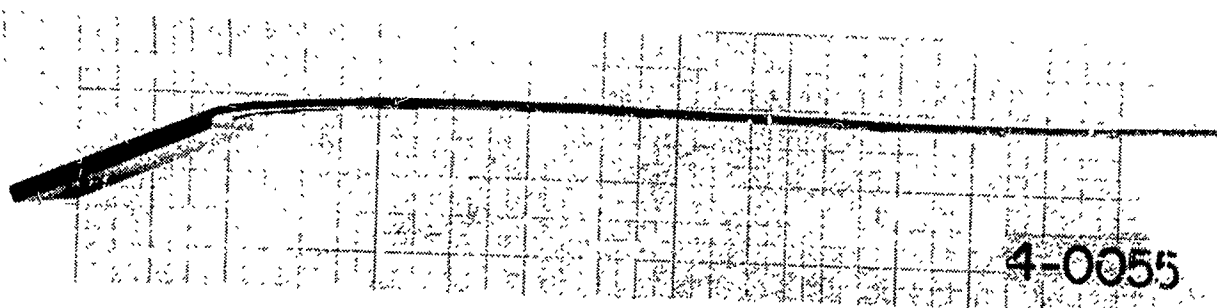
Figure 12B. Damage for Group 6 Titanium Specimen for 85 g (3 ounce) Artificial Bird Impact (Shot 4-0055).

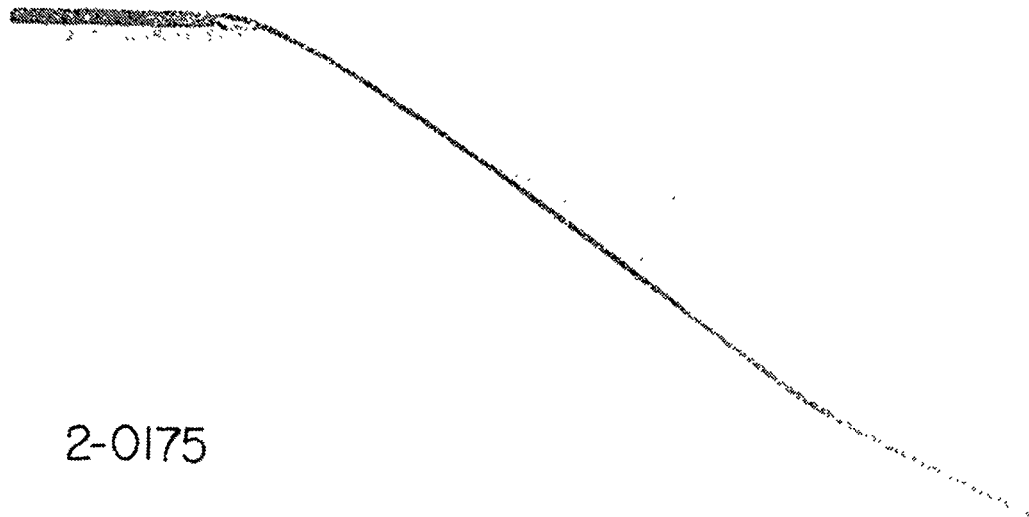
4-0054, and 4-0055. Figures 13B and 14B present photographs of the damage for the strain data impacts of Shots 2-0175 and 2-0176, respectively.

Figure 13B. Damage for Group 6 Titanium Specimen for 85 g (3 ounce) Artificial Bird Impact (Shot 2-0175).

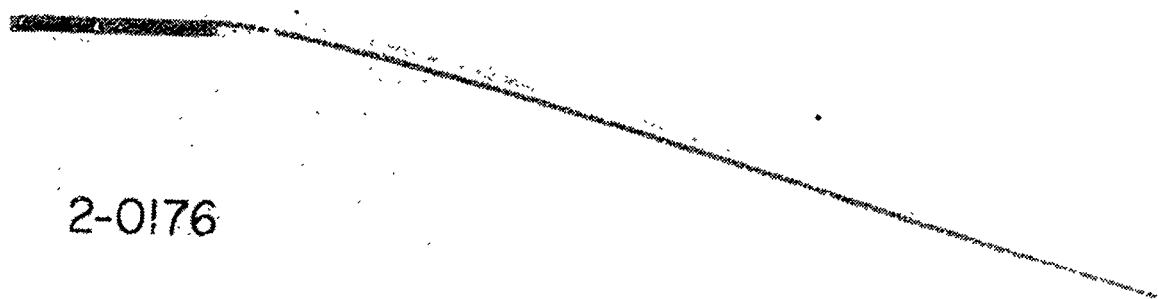
Figure 14B. Damage for Group 6 Titanium Specimen for 85 g (3 ounce) Artificial Bird Impact (Shot 2-0176).

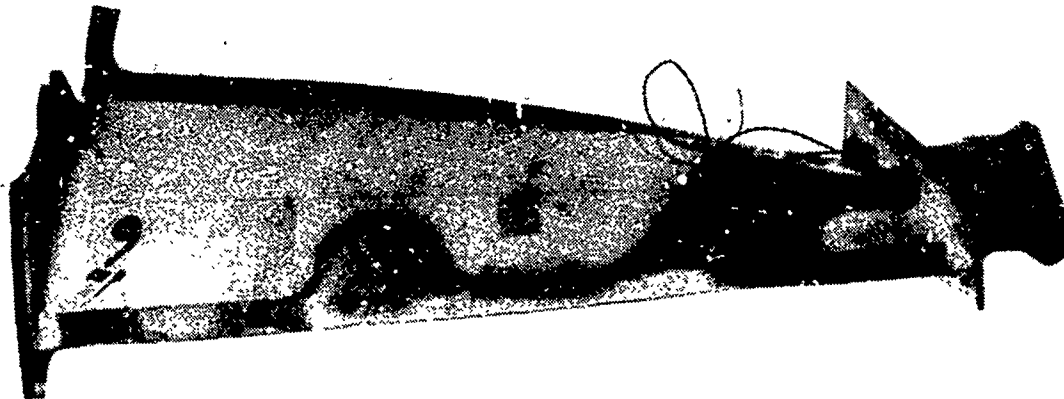
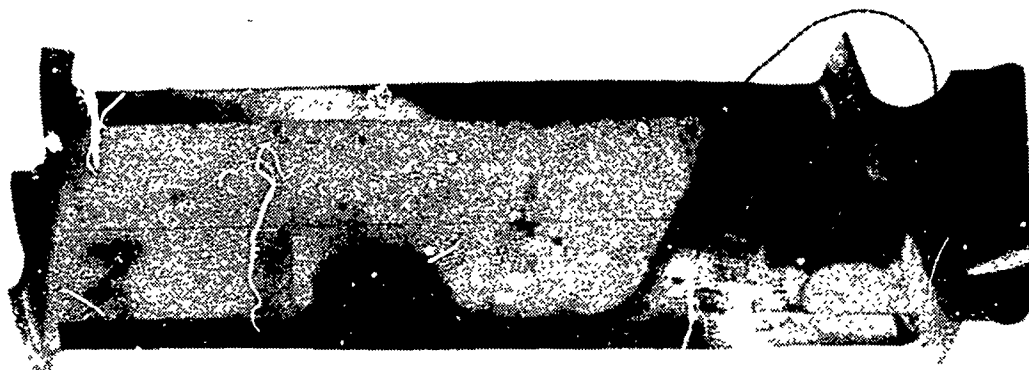
Figure 44 B. Damage for Group 3B F101 Titanium Blade Due to 680 g (1.5 pound) Artificial Bird Impact (Shot 2-0019).

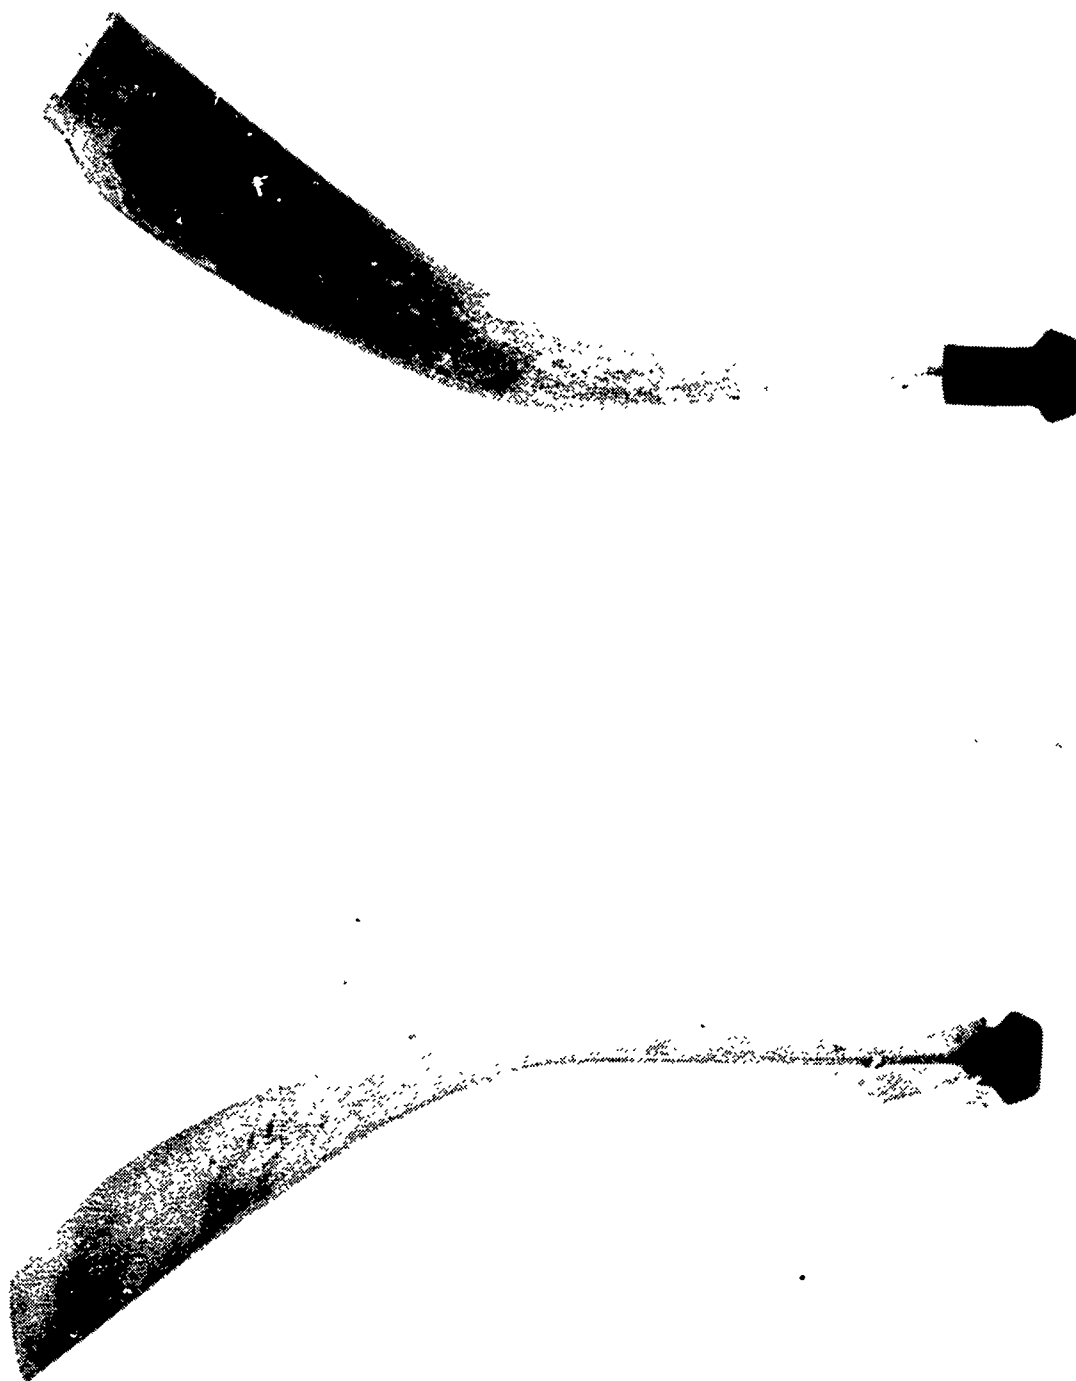
Figure 49B. Damage for Group 8B J79 Stainless Steel Blade to 680 g (1.5 pound) Artificial Bird Impact (Shot 2-0015).

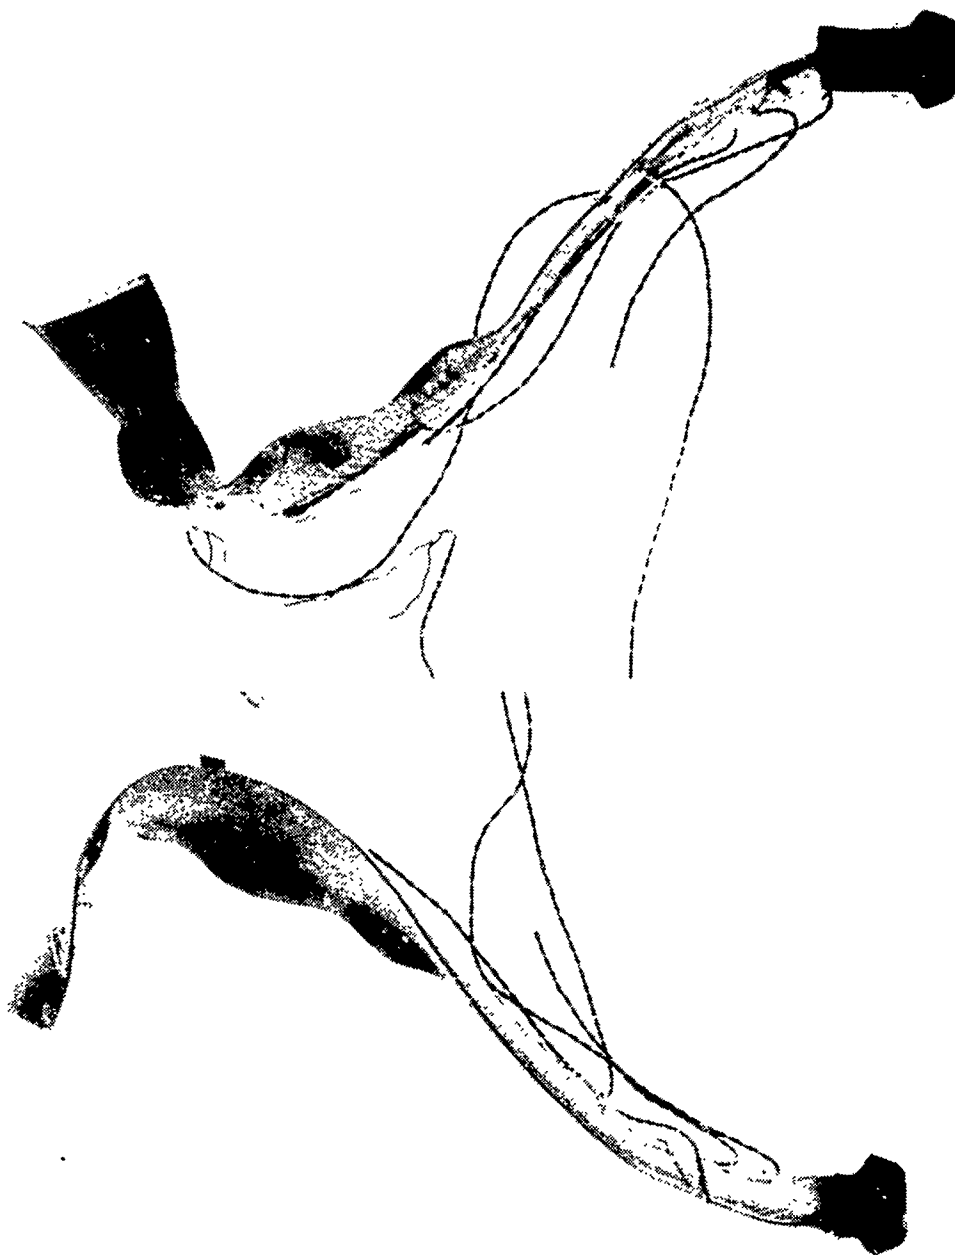
One leading edge impact (Shot 2-0024) using the 680 g (1.5 pound) bird generated severe damage in the form of bowing 9.8 cm at the impact site. The blade was knocked out of its mounting fixture and hit the back of the target tank. The impact velocity for the 70 percent span impact was 254 m/s.

Figure 50B. Damage for Group 9B J79 Stainless Steel Blade Due to 680 g (1.5 pound) Artificial Bird Impact (Shot 2-0024).

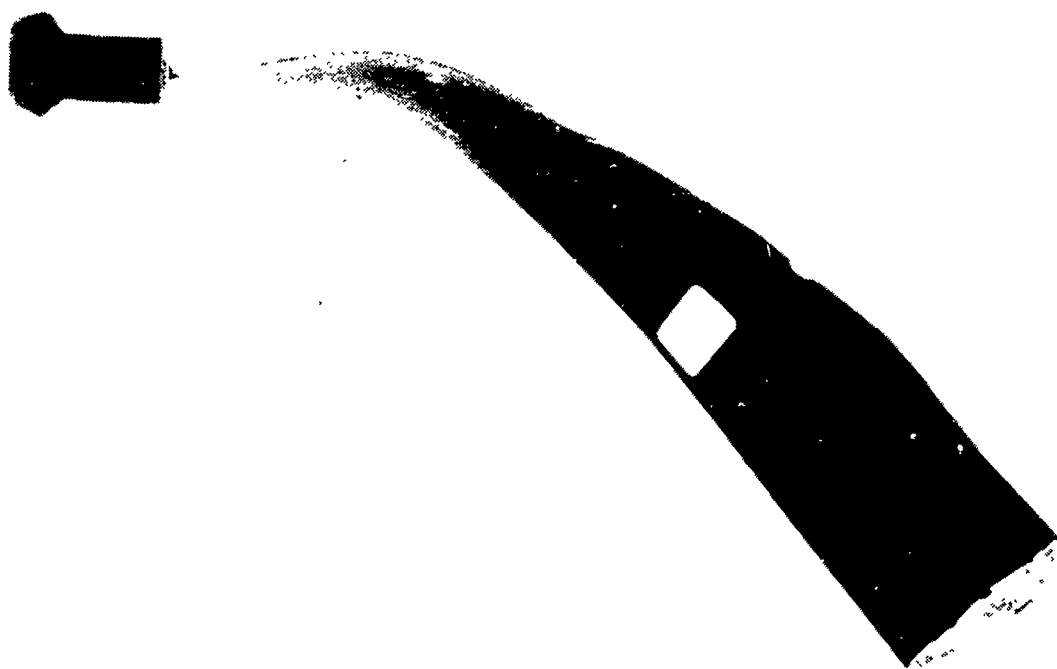
2-0226

Figure 52B. Damage for Group 10B J79 Stainless Steel Blade Due to 5.08 cm (2.0 inch) Ice Ball Impact (Shot 2-0226).

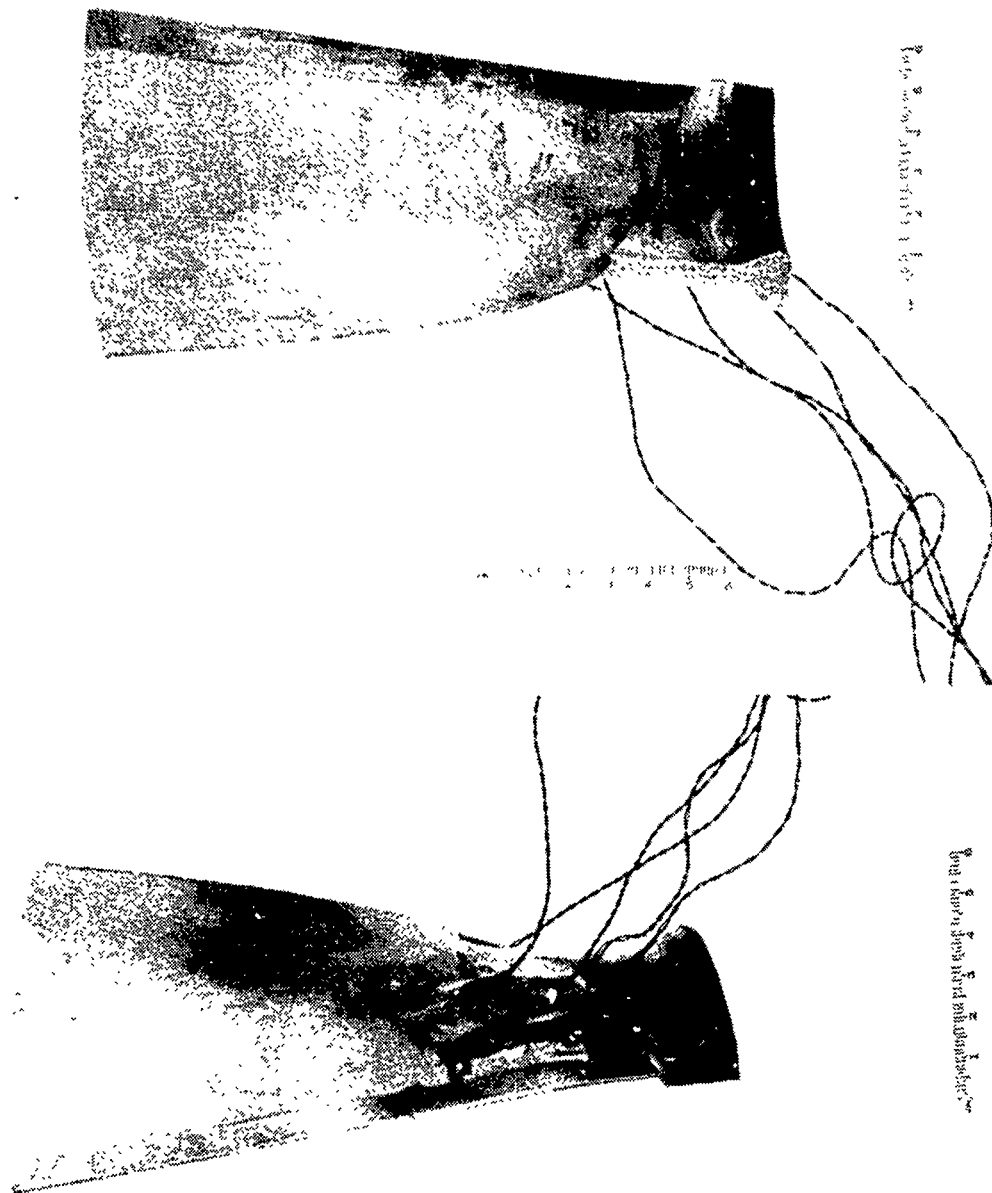
Shot 2-0023 at a velocity of 419 m/s generated damage in the form of a crack across the chord 5.08 cm long starting from the leading edge surface. The impact mass could not be determined for this impact. Also, the balsa wood sabot hit the target after the bird. Figures 257 through 262 give strain versus time curves for the impact. Figure 2A of Appendix A gives the gage locations for this series of tests. Tension is denoted as a negative strain and compression as a positive strain for this group of blades. It was impossible to determine the maximum strain rate because of noise in the data. Figures 263 through 266 show the tip deflection versus time results for Shot 2-0023 during the impact event. Figure 261 shows the

Figure 55B. Damage for Group 12B APSI Boron/Aluminum Composite Blade Due to 85 g (3 ounce) Artificial Bird Impact (Shot 2-0023).

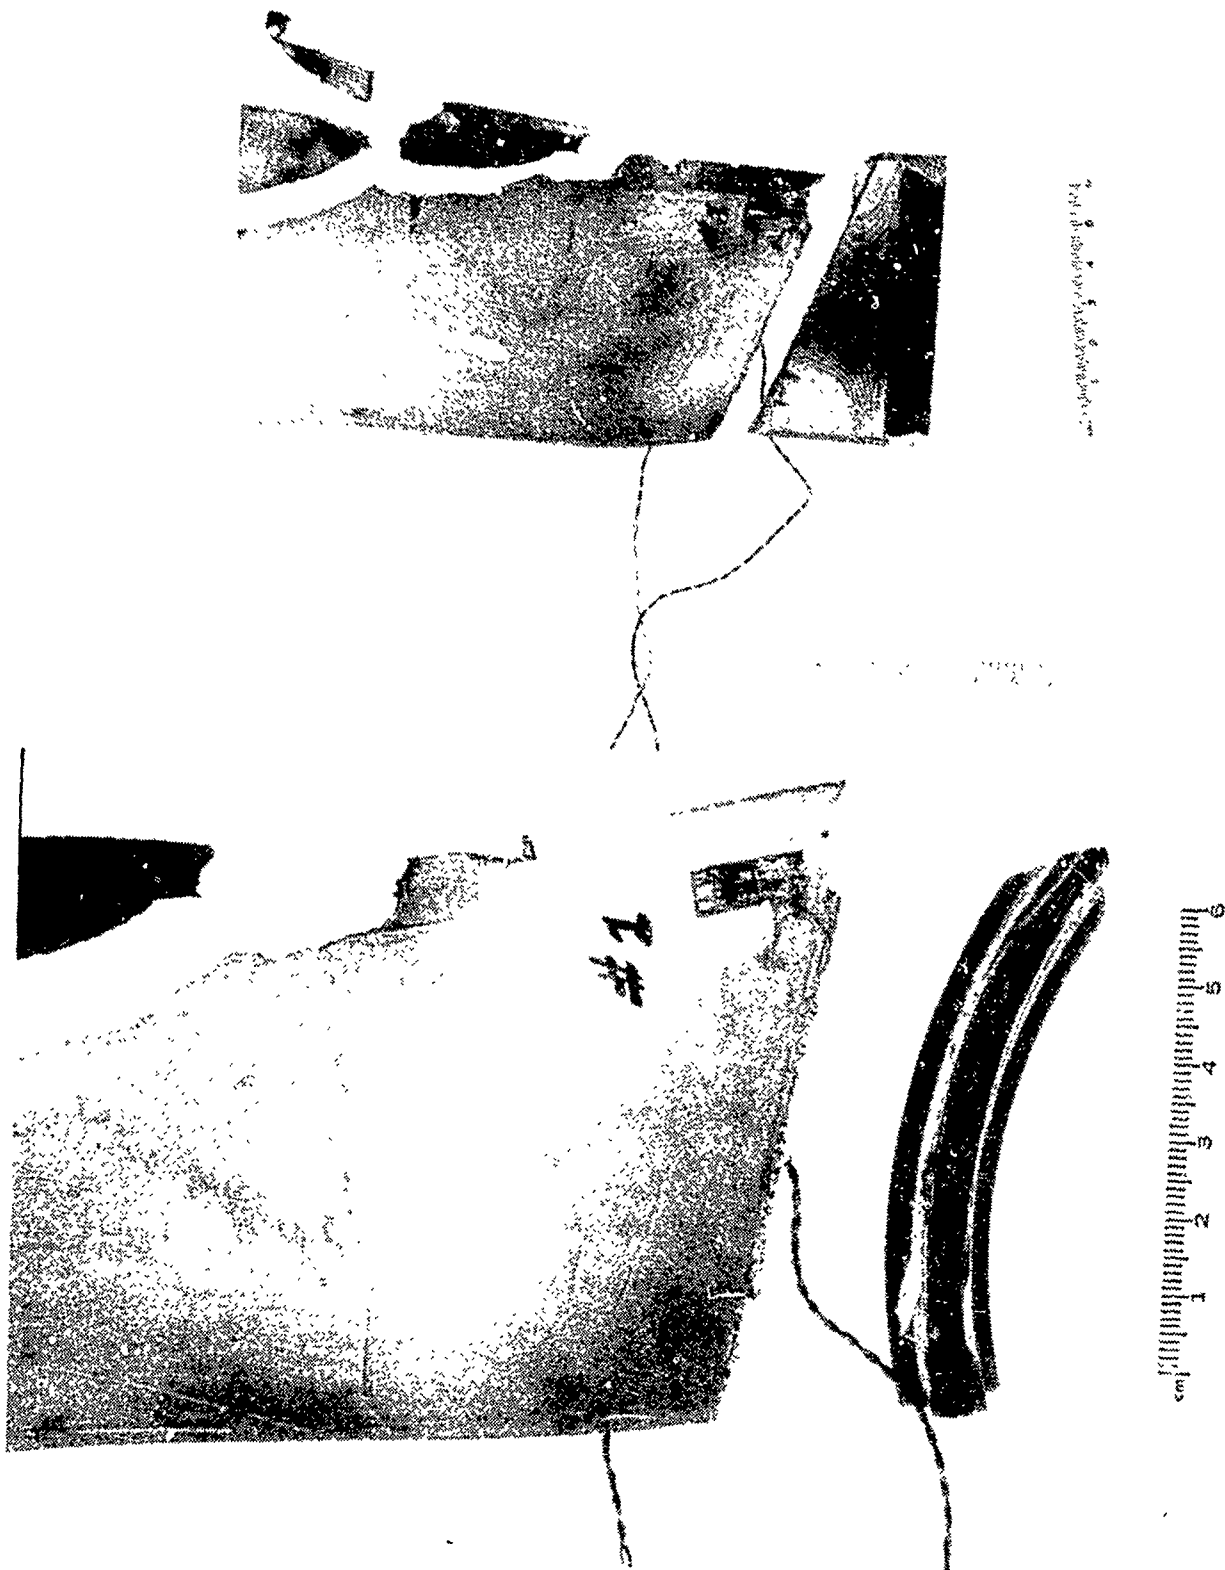
Figure 56B. Damage for Group 13B APSI Boron/Aluminum Composite Blade Due to 85 g (3 ounce) Artificial Bird Impact (Shot 2-0022).
